AINSWORTH RECOVERY

FULL REFURBISHMENT OF 1994 DYSON COMMANDER

FIRST BUILT IN 1994 FOR HARVEYS RECOVERY AND
OWNED FOR THE LAST 10 YEARS BY RICHARD
AINSWORTH THE EQUIPMENT FROM THIS LEFT HAND
DRIVE SCANIA 142 HAS BEEN FULLY RESTORED AND
FITTED TO A 2006 DAF CF 85 480 6X4 AND IS NOW
READY FOR THE NEXT SEVENTEEN YEARS OR MORE

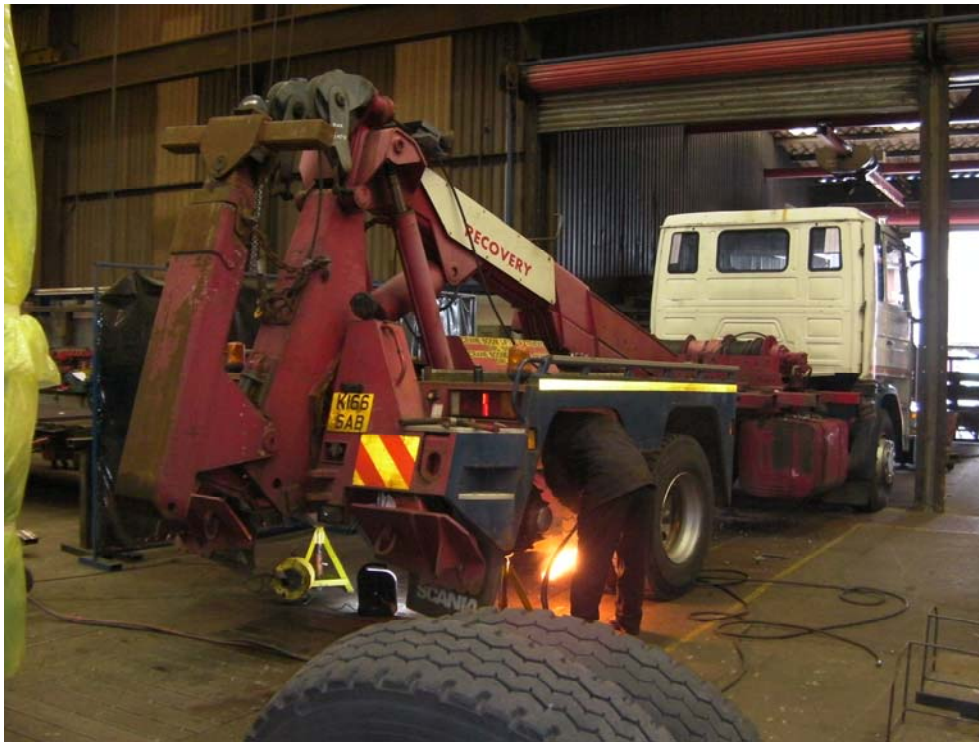
Stage 2 – Preparation & Removal

All the bodywork & the original flyer are removed to expose the equipment in preparation for removal. Repairs that can be undertaken whilst on the original chassis are completed. The old Underlift & then the neck are removed and finally the equipment is lifted off the old chassis & placed on stands in the workshop. Having been built around the chassis & fixed in place for seventeen years this process is not without its difficulties & requires extensive cutting before its finally free of the chassis. The main lift cylinders & the hinge cylinder are removed for repair, their retaining pins being so severely corroded into place that it becomes necessary to cut them out.

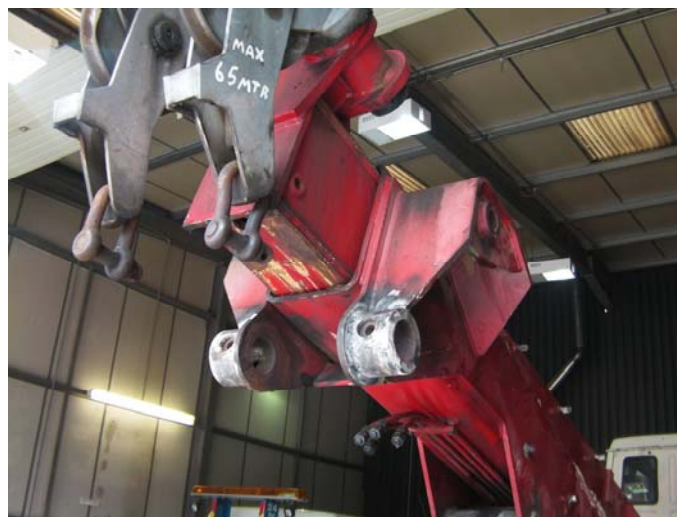
Stage 3 – Refurbishment of Sub-frame & Main Boom

All the remaining worn, damaged or faulty parts are taken off the equipment reducing it back to just the sub-frame & main boom. All the hoses & control valves are removed. All the original chassis mounting cleats are cut off & dressed back. The valve bank complete with its cradle is removed to protect it from damage during further work to the sub-frame & main boom section.

The main lift cylinder lower mountings which suffered collateral damage during removal of the leaking cylinders are replaced with the newest version. Old & redundant body out-riggers are cut off & new ones positioned to suit new bodywork. The O/S rear jack casing which had been twisted out of place is cut free from the frame & repositioned. Corroded cosmetic metal work to both the frame & jack casings is either patched or replaced with new. The main hinge pin bosses to the original boom were reinforced to support the new Underlift.

The winch head sheaves are dismantled & damage to the wheels carefully repaired. The cable tensioner is dismantled & inspected with a number of new parts being ordered.

During this process the new chassis which started life as a tractor has its wheel base extended to suit the performance of the new Underlift. Various redundant parts from its first life are removed & damage / modifications to the original air & electrical systems are carefully restored back to O.E.M standards.

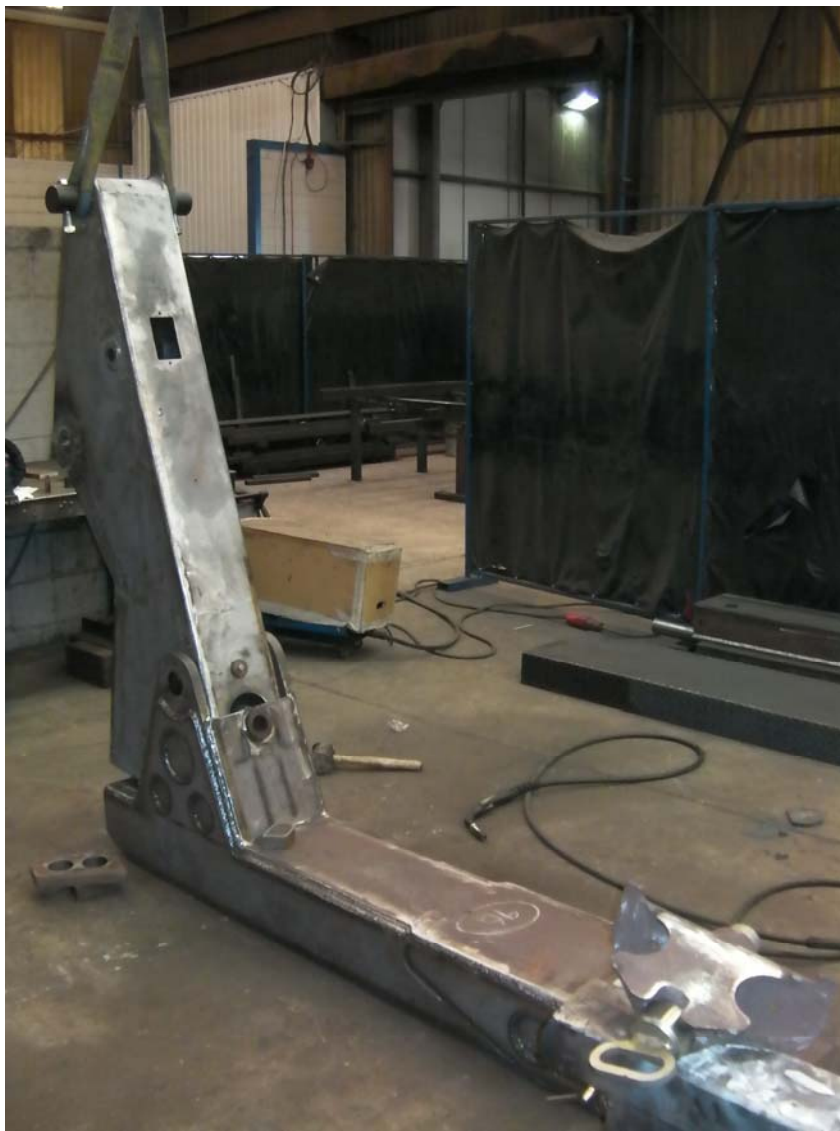
Stage 4 – Upgrade & New Parts

The original neck assembly which had been removed earlier was fully shot blasted & inspected for fatigue damage. Several weld seams were ground out & re-welded. Worn pin bosses were cut out & replaced with current version. Following this a number of new plates are added to up-grade the fabrication in-line with a 2011 version. Finally a complete new Maxi-reach Underlift was produced & matched to this refurbished neck.

A new front towing bracket is manufactured to locate in the original towing jaws & bracketing added to carry a light rail with four spot lamps.

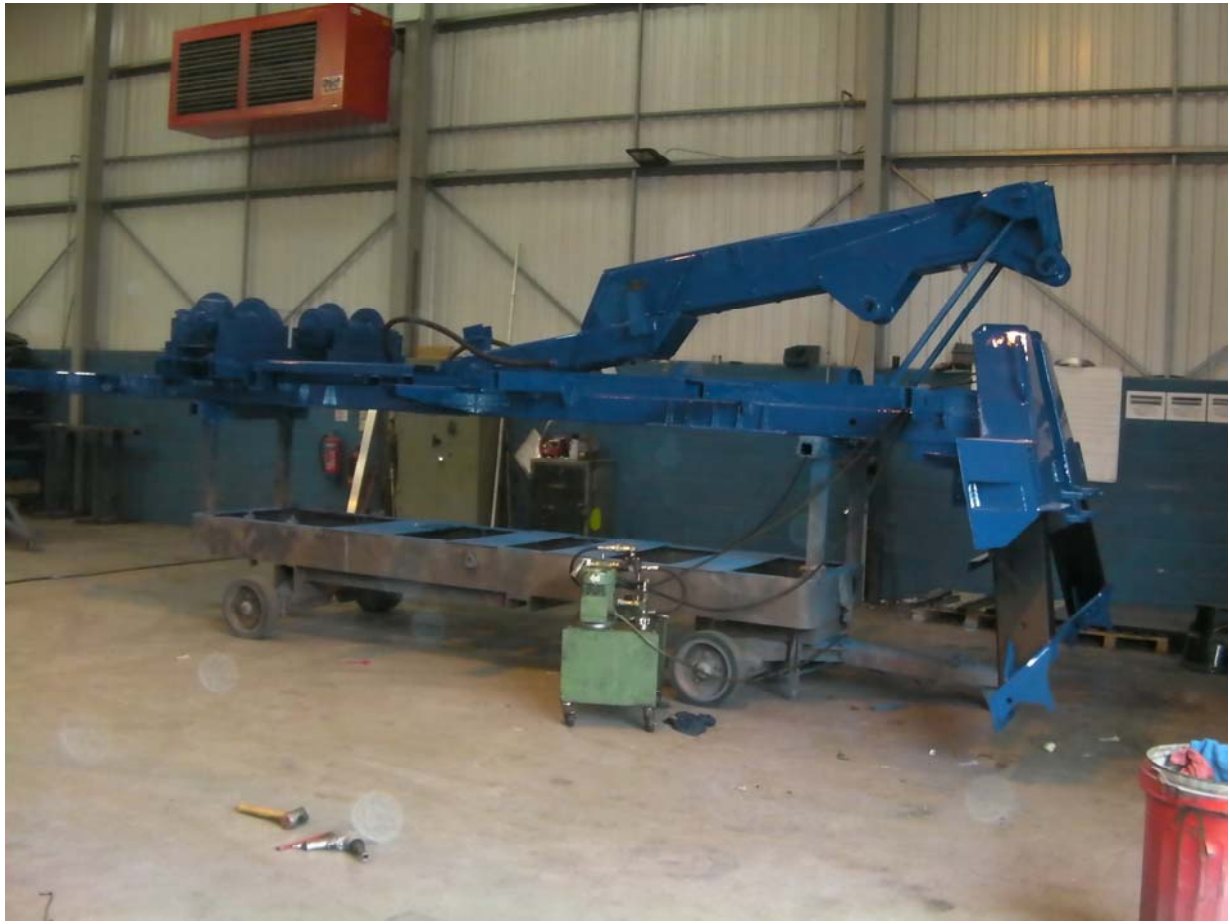
Stage 5 – Fitting to New Chassis

Once restored the sub-frame & boom are fitted onto the new chassis. The frame is extended at the front to match the new chassis. Particular attention is given to the rear chassis fixings around the jacks, this area being heavily reinforced to support the rear jacks.

The new chassis already has a PTO but this is not a suitable match for the existing pumps & drive splitter box so the PTO is replaced. Next the original drive splitter box is fitted to the new chassis together with a new drive shaft.

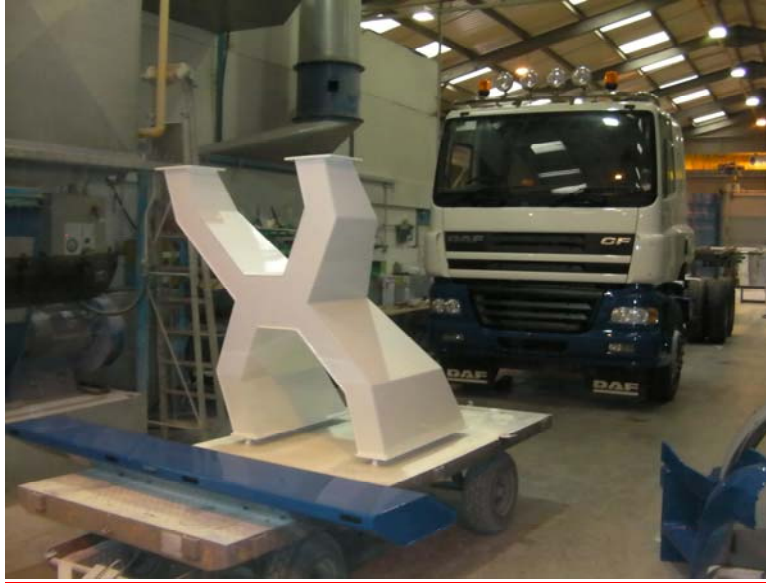
Stage 6 – New bodywork, flyer & ballast box

Four new modular body shells are produced, fitted to the frame & trimmed to suit the chassis. The new body system is then racked out to the customer's specification. A new 'X' type flyer & ballast box are also added to complete the restoration.

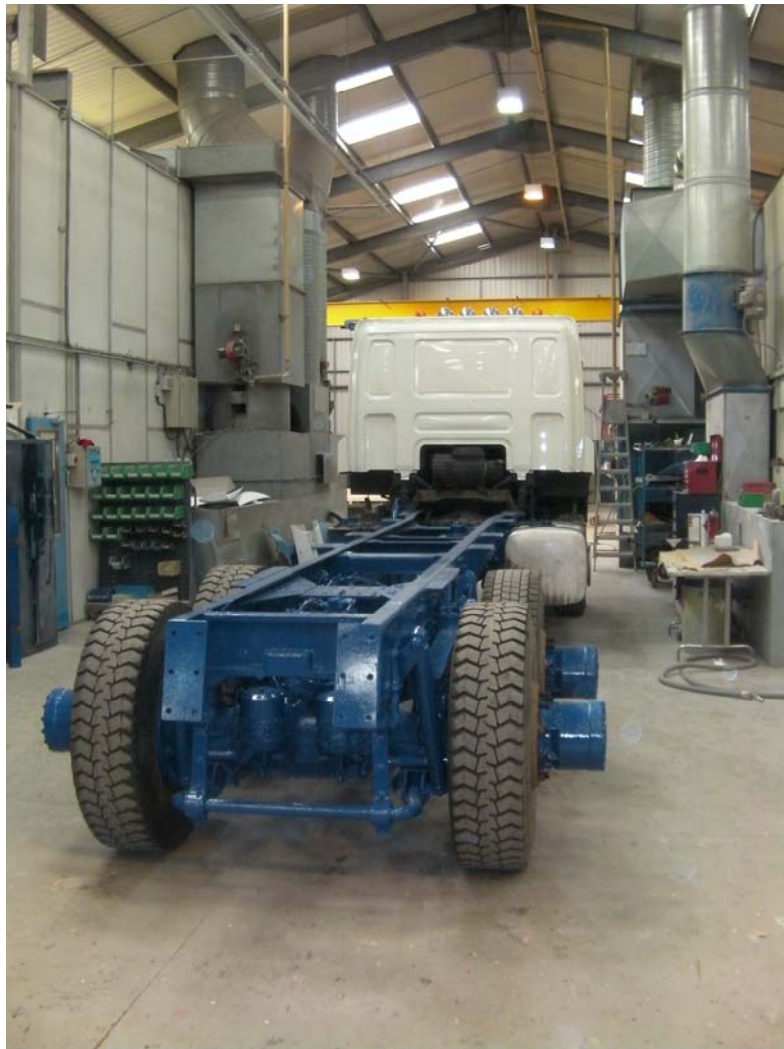
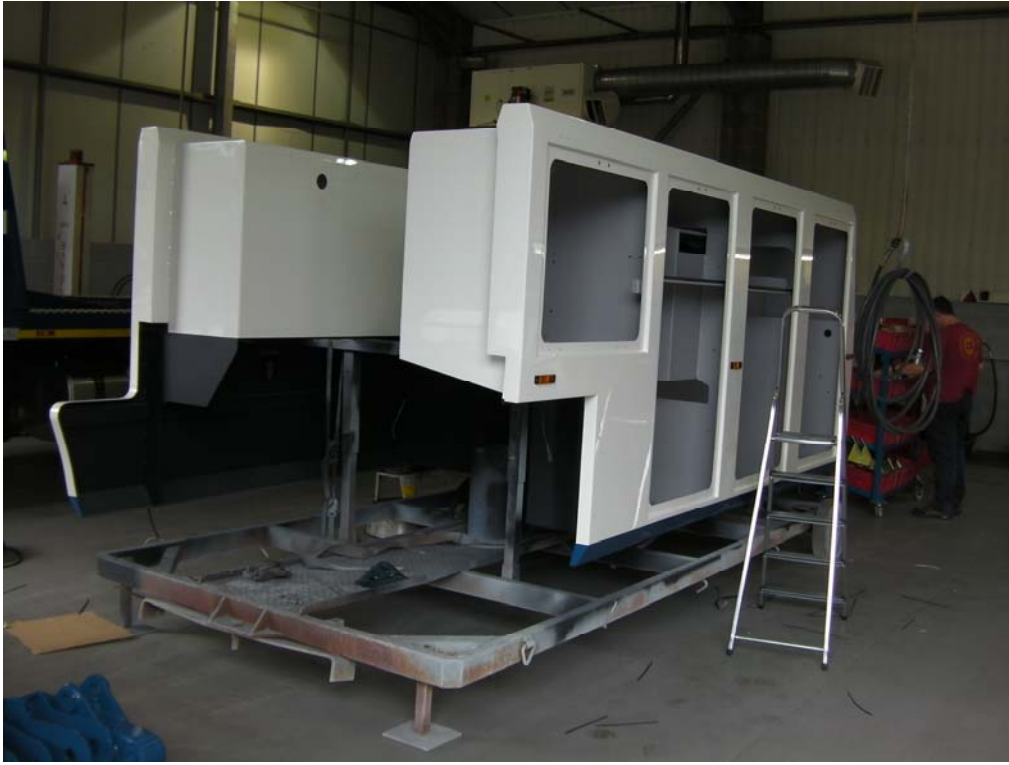
Stage 7 – Painting

As with all our products each section is fully prepared & painted separately before being passed on to the assembly building as a kit. By this time the two lift cylinders & hinge cylinder have returned from extensive renovation & are also painted ready for assembly. To complete the process fully the cab & chassis were also repainted to original factory standards in the customer's fleet colours. During this process a number of cab panels were replaced to help to restore the cab to a near showroom finish.

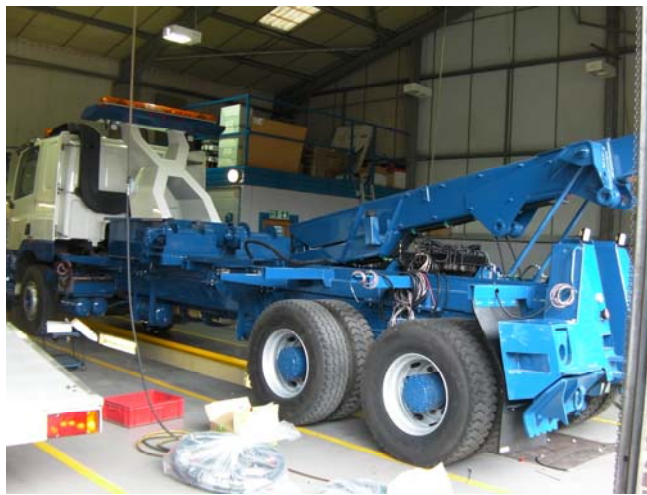
Stage 8 – Final Assembly

Here we find all the individual parts being assembled in to the new machine through the same process as if this had been a completely new build. New hoses are fitted together with the original control valves which have been cleaned, adjusted & repaired.

A complete new wiring harness is produced & installed to the current specification using the control panel you would see on a 2011 machine.

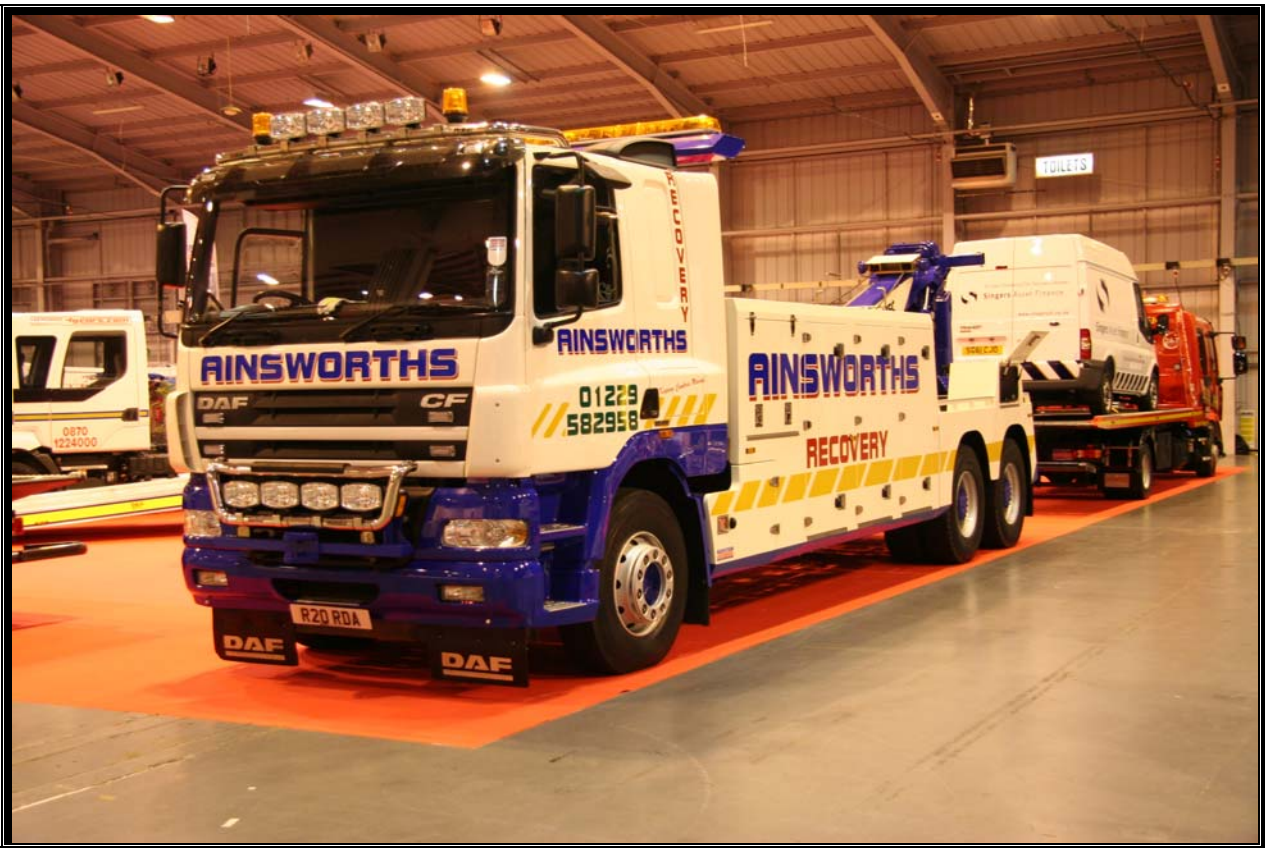
Stage 9 – Finishing

The completed vehicle is fully tested & re-certified. Next the customer's livery is put on, followed by a Roadworthiness inspection through V.O.S.A confirming the new vehicle is fully roadworthy & ready to work.

The net result is that with its new number plates you could be forgiven for assuming this is a brand new vehicle with brand new equipment, ready for another seventeen years working life.
